Laser-induced damage and defect analysis of calcium fluoride window caused by the high pulse repetition rate of ArF excimer laser radiation

Daisuke Tei, Masakazu Hattori, Takahito Kumazaki, Yasutsugu Usami, Junichi Fujimoto, Hakaru Mizoguchi Gigaphoton Inc. 400 Yokokurashinden, Oyama-shi, Tochigi 323-8558, Japan

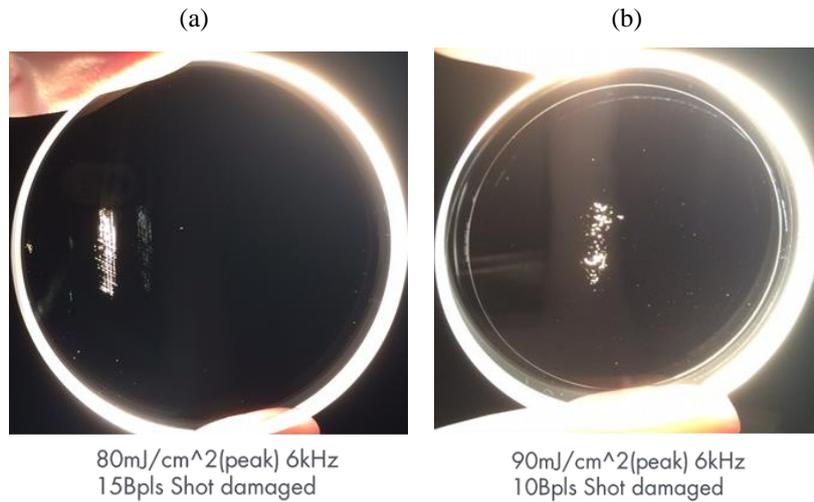
Surface damage is one type of element degradation phenomena, and can be observed as scattering from visual observation of the optical element surface as shown in Figure 1. The phenomenon is easy to produce on no-coat CaF₂ substrates and the production of damage is not dependent on the number of shots experienced. This is a motive for considering the possibility of creating element tests (short term tests). Surface damage increases element scattering and reduces the laser system efficiency due to laser light absorption.

Figure 1. Surface damage morphology pictures. Sample had surface damage at 80mJ/cm² 15Bpls (a), and another sample was damaged at 90mJ/cm² 10Bpls (b)

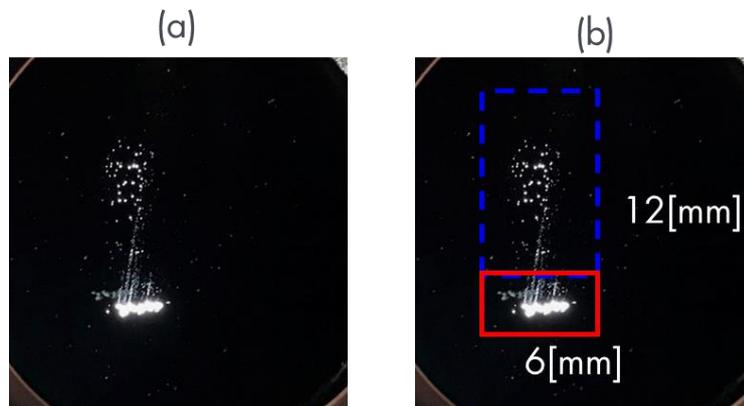
The dark field image of Sample A is shown in Figure 2. We will introduce the positions of damage with the analysis methods that come afterward using these photographs. The damage size is about 6 x 12 [mm]; it is almost the same size as the footprint of the laser beam. The intensity of the surface damage varies for each framed area – red and blue. The part framed in red indicates “extreme damage”, and the part framed in blue indicates comparatively “slight damage.” We can judge the damage intensity by the intensity of light scattering.

Figure 2. Observation results of surface damage image in dark field (a). An image divided by a color frame for each intensity of damage (b).

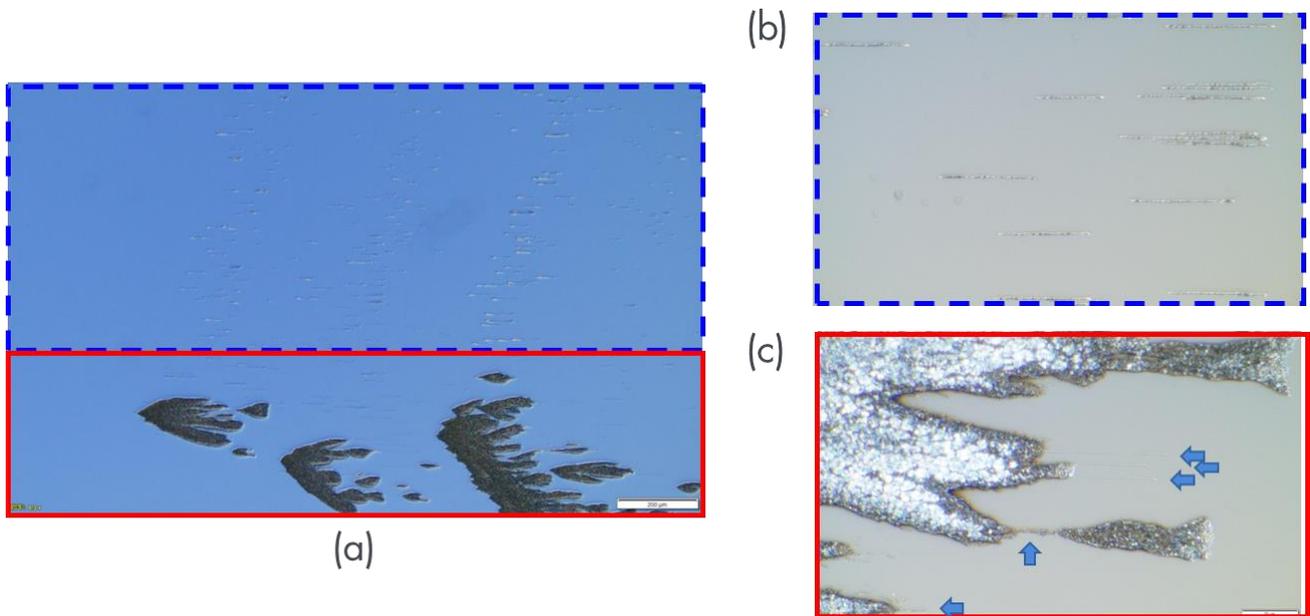
When looking at the “slight damage” in the blue frame area, one can see the damage in the shape of linear scratches. Further, the heavily damaged portion is in the shape of a bird’s foot. Also, linear scratches are seen at the edge of damage the same as the blue frame. Therefore, “heavy damage” can be assumed to be advanced deterioration caused by combining many scratches of “slight damage”. The orientation of surface damage “linear scratches” might be related to crystal orientation and laser resonance direction, etc.

Figure 3. Morphology of surface damage using Nomarski-type DIC microscope. Result of damage analysis at wide [1.5 x 2.0[mm]] range (a). (b) shows the enlarged blue frame of (a). (c) shows the enlarged red frame of (a). Both ranges are [0.15 x 0.2 [mm]].

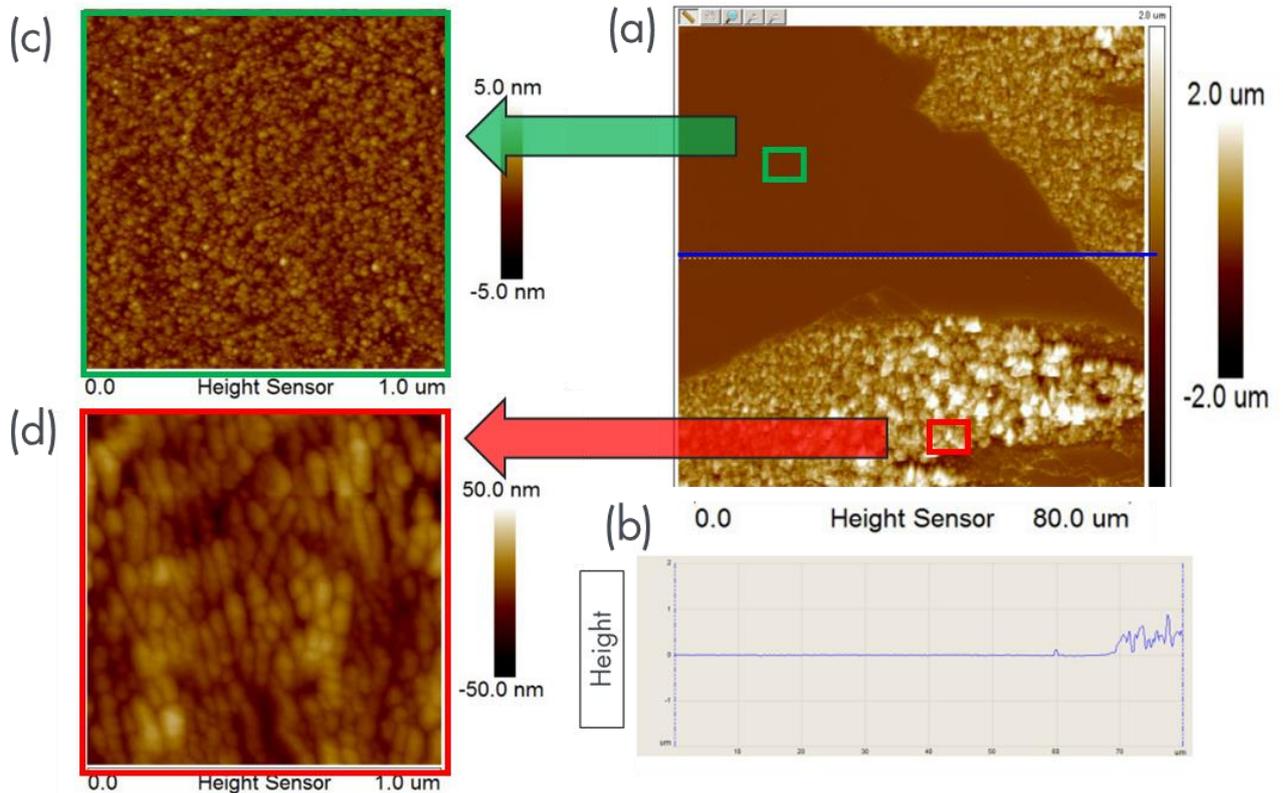
Compared with the color scale, we can see that almost all the damaged area has a convex shape with regard to the substrate from Figure 4-(a). Further, in Figure 4-(b), the vertical axis shows the height of blue line in the center of Figure 4-(a). In the blue line, the right area has damage and left area is stable CaF_2 , so we can see that the damaged area is above the stable surface. When it is compared with the measurement results of Nomarski, scratch-like convex shaped damage like a small part of damage occurs on the surface of the element, and as the scratches are joined and the region expands, we can see that the region grows due to large damage, including deep valleys, rather than the substrate, due to the increasing intensity of the unevenness. In the area where the damage was large, the damage was about $\pm 2 \mu\text{m}$. This is similar in shape to a protrusion called a nanohillock in reference [4].

As shown in Figure 4-(c), when the undamaged part was enlarged, the unevenness of the polished surface was several nm or less, and it was observed that there was no damage, as expected. Figure 4-(d) is a further enlarged diagram of the damaged part, the undulations observed at 80 μm square were observed as large waviness, and aggregates of fine clusters (grains) of several tens of nm were confirmed. As this has not been observed in the undamaged area, we did not analyze further, but some shape deformation of CaF₂ is presumed.

Figure 4. Morphology of surface damage using AFM (Atomic Force Microscopy). Result of damage analysis at wide [80 μm square] range (a). (b) shows the height of the blue line in (a). (c) shows the enlarged stable CaF₂ in (a). And (d) shows the enlarged damaged area. Both ranges are [1.0 μm square].

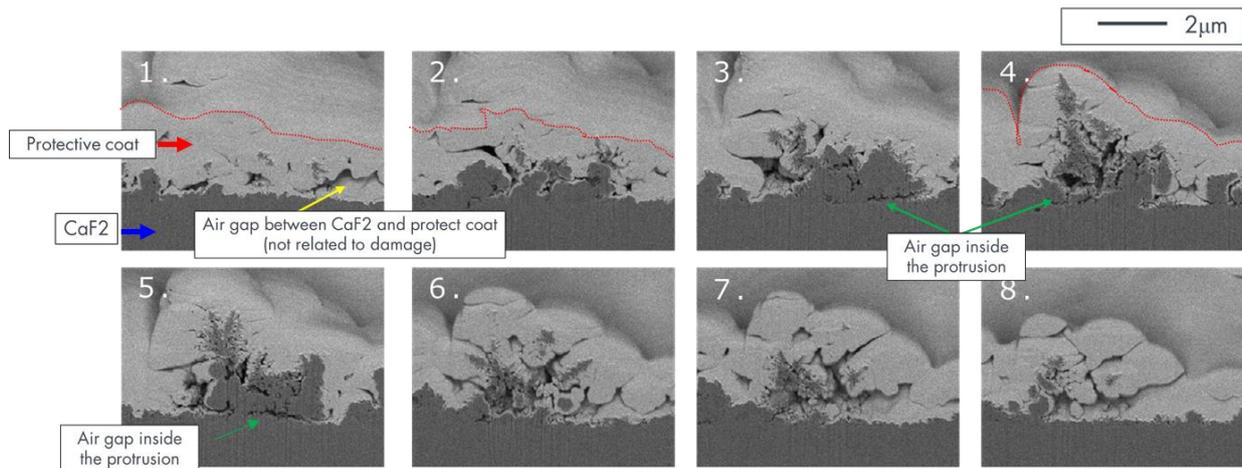
The analysis results in figure 5 indicate the results of slicing into eight parts for each 200 nm of a protrusion observed in the analysis up to now. It can be seen the protruding part has many defects and is sparse with respect to the normal CaF₂. In other words, there are many voids inside the protrusion, and it seems that the outermost surface is bulging. (3,4,5th view).

Figure 5. 3D image of surface damage using Slice and View.

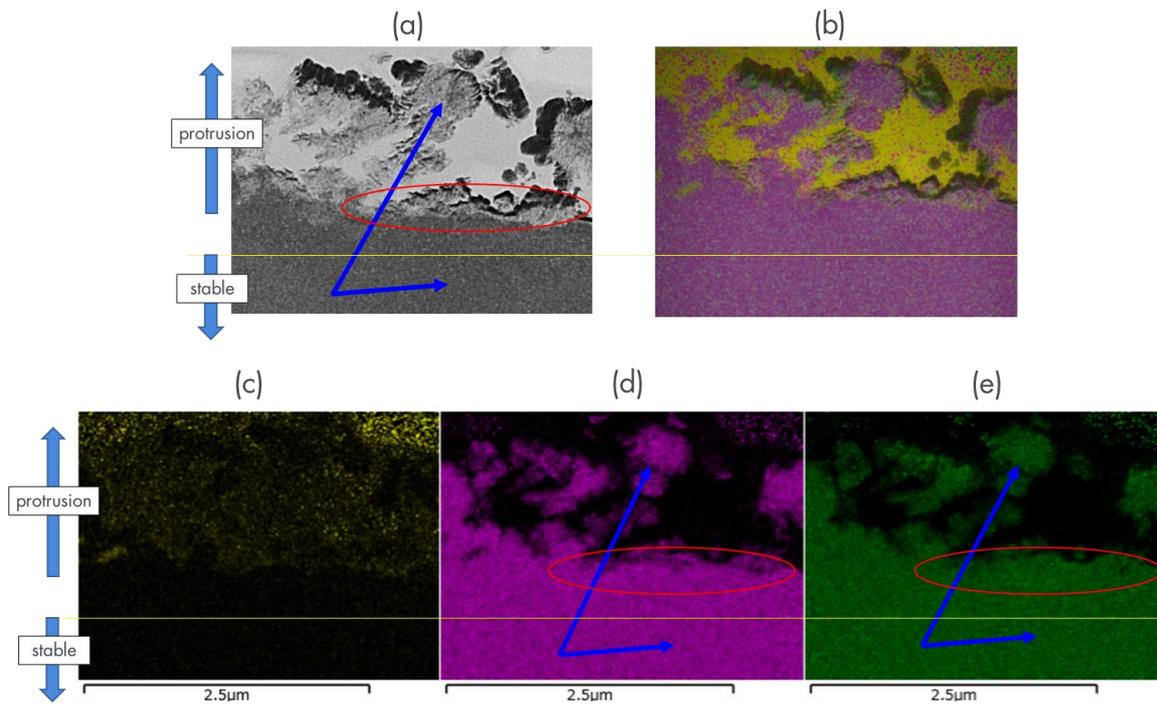
When looking at the analysis results in Figure 6, as indicated by the blue arrows in the TEM image, regardless of the visibility of a difference in intensity in the protrusion and substrate portion, no intensity was observed in the Ca or F in the EDX image. This suggests that the element crystallinity has deteriorated. These phenomena can also be observed in the element subsurface. Further, when the results of component analysis are discontinued, there is a part where the fluorine is missing in a part of the normal substrate and the components of that part can read that the fluorine atoms were substituted with oxygen atoms.

Figure 6. Morphology of surface damage (one of protrusion) using TEM-EDX. (a) shows a TEM image, and (b) shows a TEM-EDX superimposed image. (c)-(e) is an image map of component analysis by EDX, “oxygen” shows in (c), “fluorine” shows in (d), and “calcium” atoms show in (e).

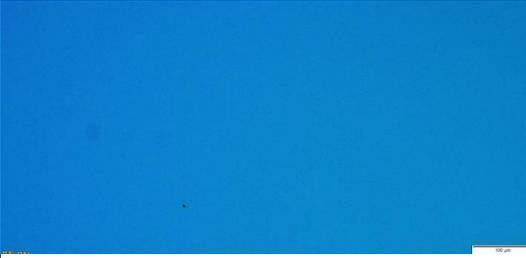
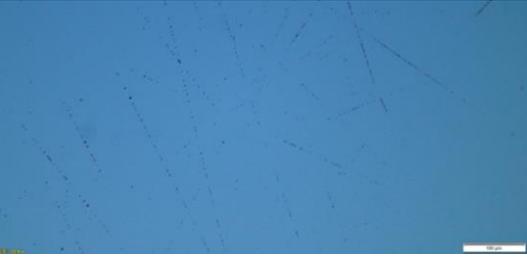
Table 2. Verification test results

We used “dark field image,” “Nomarski-type DIC microscope” and “Zygo New View” for the elements after irradiation in each pattern to confirm the presence or absence of damage. We did not observe any change whatsoever from the initial conditions in the elements for pattern 1, whereas in pattern 2 we confirmed a clear change that could be judged visually. We observed forms that closely resembled scratches during polishing in convex form. Continuing laser irradiation into the future, we can assume that the protrusions will grow linearly and further, their area will enlarge

Result	Non damaged	Damaged
